**BURIED ONSHORE PIPELINE COATINGS**

# 50 YEARS OF IN-GROUND CORROSION PREVENTION

### **PROJECT DATA**

Location	Kings Park, WA
Client	Water Corporation
Products	Denso™ Tape
Date	More than 50 years ago
Ref No	B044

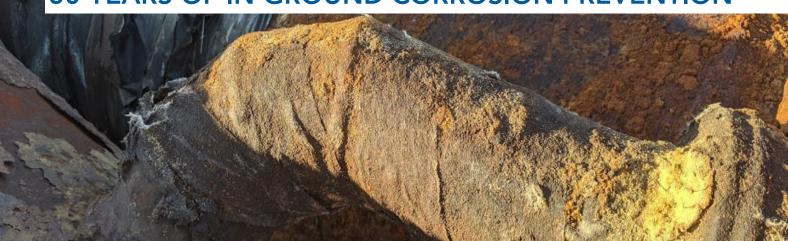
Water main wrapped in Denso™ Tape more than 50 years ago.

The Denso™ Tape removed from the pipe has a cloth carrier as opposed to the synthetic carrier used since 1969 in Australia, indicating that this particular pipe wrap has provided over 50 years of in-ground service with the pipe still showing no signs of corrosion on its surface. Denso's Petrolatum Tapes have a proven track record providing above-, below ground and underwater protection for pipelines and other infrastructure dating back more than 80 years. Denso's petrolatum tape wrap systems can easily be applied by hand to most surfaces in a wide variety of low to high temperature environments.
